Damage:

Description of issue:

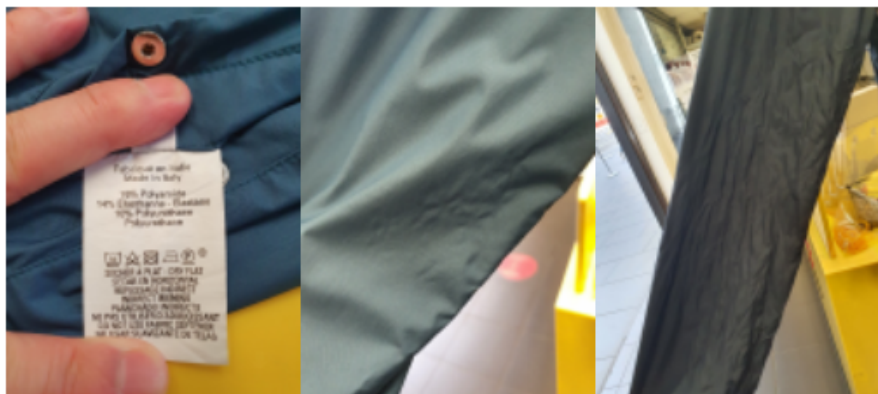
This jacket was cleaned recently by a DIA member, and it is a good example of a relatively common problem - separation of the fabrics and separation of the coating on the jacket designed to give protection against wind and rain.

Manufacturers are known to use many different products to help protect against inclement weather and in this particular instance, if the materials in this jacket were unpicked then we would see the cause of the problem being the above-mentioned separation.

This garment has care instructions with dry clean P, this denotes the solvent perchloroethylene and perc is the strongest solvent available and in Australia is the most widely used. The garment also carries washing instructions so that either drycleaning or washing is permitted. In this instance the jacket was washed in cold water and the wrinkling appeared and then drycleaned with the wrinkling still remaining.

It was noted that the care label had the international symbols instructions that tumble drying is prohibited and this is an issue as all dry cleaning requires tumble drying. It is possible that the label is referring back to the washing instructions but then if this is the case then the manufacturer should make this clear.

This is not the dry cleaners fault it is a fault of manufacture. In this instance the drycleaner was a DIA member, and we were able to assist him providing him with some Technical Analysis Bulletins (TABs) from the DLI which supported that it was a manufacturing error.
